## **STUDIES REGARDING THE DETERIORATION AND DEGRADATION OF OLD PANEL PAINTINGS UNDER THE INFLUENCE OF ENVIRONMENTAL FACTORS**

*This paper presents different progressive effects of deterioration and degradation of panel paintings, a result of environmental factors' action during exhibition or storage. It has been analyzed both the support and the components of the painting layer. There have been studied panel paintings from XIX - XX<sup>th</sup> century, whose panels are made of few planks, joined with dowels and crossbeams. The dimensional changing through swelling and shrinking or the modification of panels flatness, determined by the variation of environmental factors, led to tensions which created cracks, fractures of the wood, affecting also the painting layer. The microclimate fluctuations affected physical (deteriorated) and chemical (degraded) the painting layer. The results are cracks, cleavages, embrittlements, discolorations. The paintings exposed to harsh climate conditions reached a pre-collapse and even collapse state. The observations took into account the interactions between the different structural elements of paintings under the influence of environmental factor

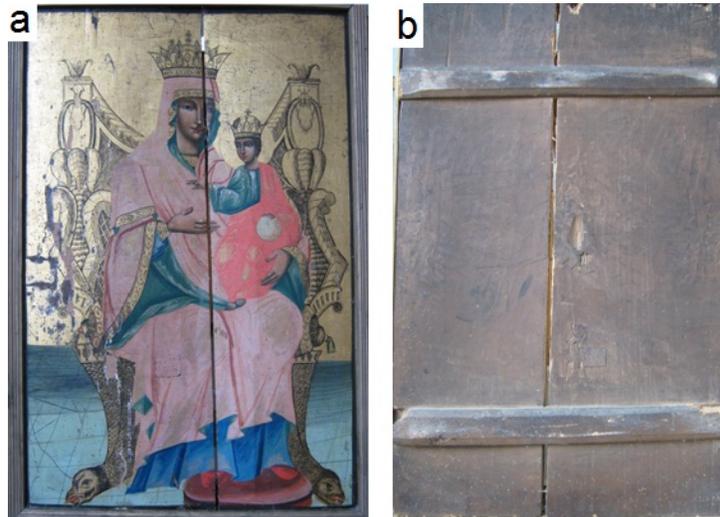
**Fig. 1**  
**Icon Holy Virgin with Child:**  
**a - general view obverse and b - general view reverse.**

The panel of the icon was made of two planks fixed with dowels and glued together. The icon presented a frame fixed with modern nails on the obverse and edges. On the reverse it had two crossbeams with dovetail section (Fig. 1b). The microclimatic variations (high humidity due to infiltrations in church's walls, and anthropic factor; variable temperature depending on the season and the frequency and duration of rituals in the church),

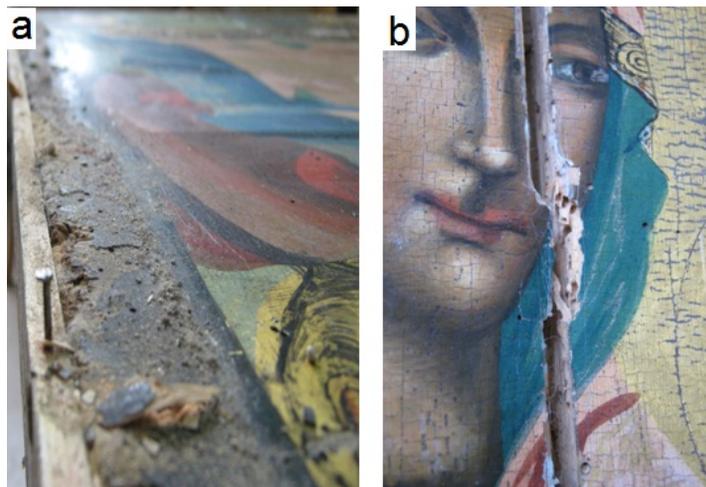
**Fig. 2**  
**Icon Holy Virgin with Child:**  
**a - detail of the fractured panel showing the traces of xylophagous attack and**  
**b - nails, dust traces, lacunae observed at the frame removal.**

the frame and crossbeams led to the stress of planks and panel's fracture (Fig. 2a). Also, there were observed cleavages and losses of painting layer in the fractured area and randomly, on the surface. The frame favored the accumulation of non-adherent dirt (Fig. 2b), and the developing of lacunae in the painting layer. The intense xylophagous attack made the support very fragile on certain areas, and it needed in-filling.

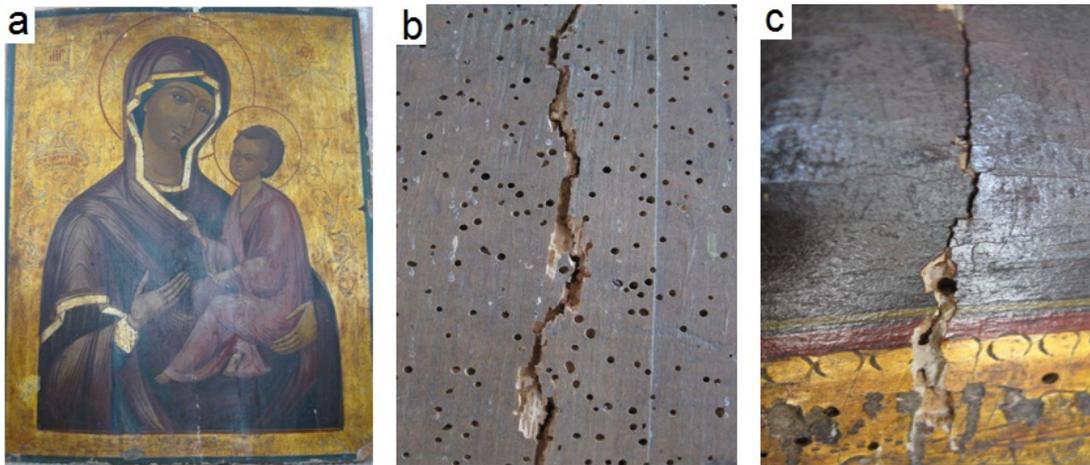
**Fig. 3**

***a – general view; b – fracture of the frail support; c- cleavage with lacunae of the painting layer, in the area corresponding to panels fracture.***

The icon presented a panel made of two boards glued together, with grooves for crossbeams, but with the crossbeams missing. The wood was very brittle because of the xylophagous attack and presented a longitudinal fracture due to incorrect manipulation on the reverse of the support, partially visible on the obverse. The ground layer, 1,00mm thick, made of calcium carbonate, was frail. The support fracture led to cleavages and lacunae in the painting layer.

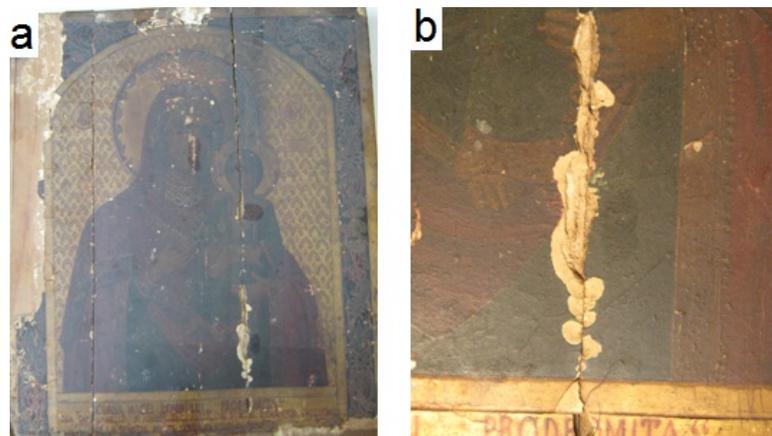
**Fig. 4**

***a - general view; b - detail of the lacuna in the painting layer.***

The icon was painted on a panel made of three boards joined with glue and nails. Also, the crossbeams were fixed with long nails, which came out on the obverse of the panel. In time the wood shrunk and tensioned and led to the appearances of cracks in the painting layer. The rigid and frail ground (made of calcium carbonate) had detached on certain areas of the panel and had been lost. The image was hardly readable because of the adherent dirt.

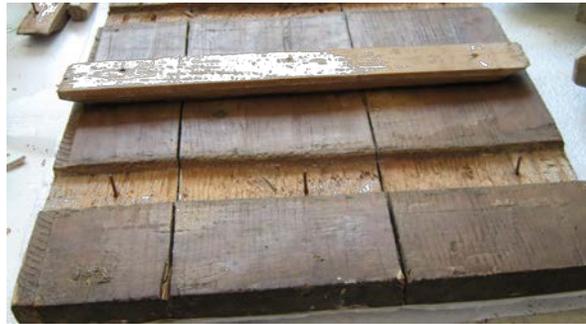
**Fig. 5**  
**Icon Holy Virgin of Prodomu**  
**crossbeams removal; the nails that fixed the crossbeam are visible.**

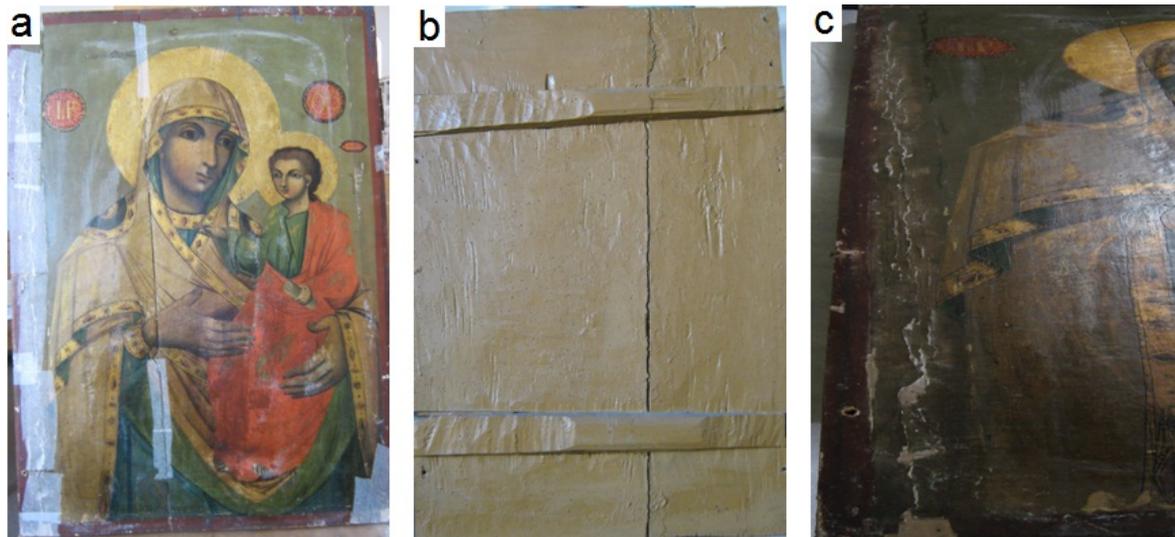
**Fig. 6**  
**Icon Holy Virgin with Child**  
**a - general view; b - the reverse of the panel painted in brown; c - the contact area with the iconostasis frame.**

The icon, painted on a panel made of two planks, joined with dowels and glued together (Fig. 6b), was installed in the church's iconostasis with screws, this way the normal movements of wood being restrained and leading to support fracture. On the left side, because of the iconostasis frame and due to microclimatic variations (heating used only in liturgical days, variable relative humidity) numerous cleavages and lacunae were formed on the painting layer (Fig. 6c). The darkened varnish presented whitish traces, probably the effect of a failed attempt of cleaning with inadequate solutions. This icon also presents signs of a quite intense xylophagous attack.
