WOODEN INTERIOR DECORATION IN POST BYZANTINE ORTHODOX CHURCHES OF THESSALONIKI

Ioannis BARBOUTIS

Assoc.Prof. - Aristotle University of Thessaloniki, Faculty of Forestry and Natural Environment, Laboratory of Wood Products and Furniture Technology,
Address: Aristotle University of Thessaloniki, 54124, Thessaloniki, Greece
E-mail: jbarb@for.auth.gr

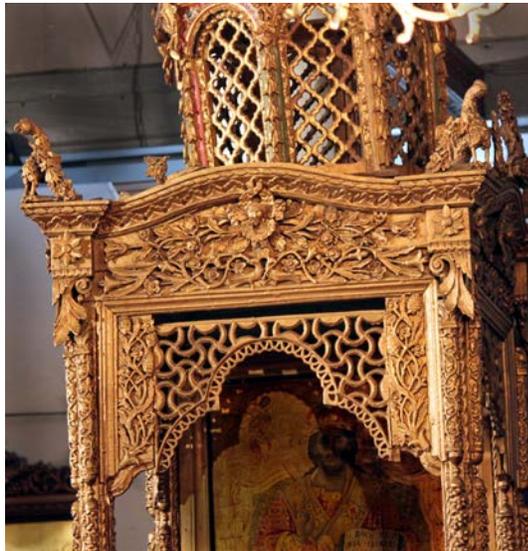
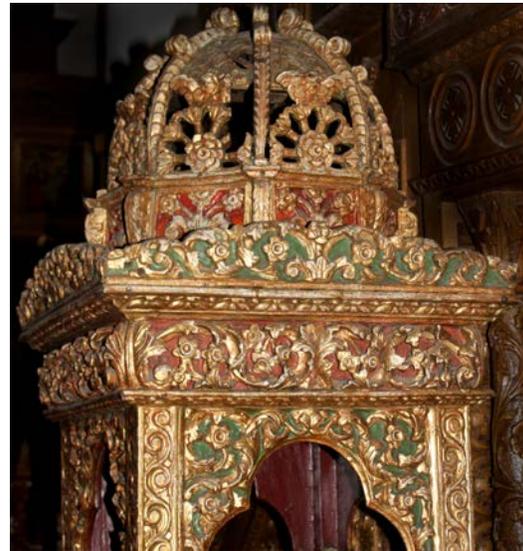
Fig. 1

***Details of wooden ecclesiastical furniture of "Agios Athanassios" church
a - Despot's Throne; b - Icon stand.***

One of the five post-Byzantine churches, called "Agios Athanassios" had replaced its original iconostasis with a new one. This church was built, in its present form, in 1818. It is a three-aisled, wooden-roof church, of basilica rhythm with 2 rows of 6 wooden columns that have an external cover of special mix of lime plaster offering the appearance of marble columns of circular cross-section. From the original wooden decoration of that time, only the Despotic Throne (Fig. 1a) and the Pulpit are nowadays still in place, which are generally in good condition, though the woodcarving details are partly covered by the consecutive repainting of these artworks. According to the code of the church, the construction and the gilding of them was finished in 1845 (Kambouri-Vamvoukou 1979). There is also an Icon stand (Fig. 1b), which, as secondary ecclesiastical furniture, perhaps has still the original gilding, even though it's quite worn. Its base exhibits signs of rot, due to the direct contact with the floor. Of great interest is also the flat, wooden ceiling, which is formed in various geometric shapes and whose construction must have been implemented during the church repair, after the fire of 1890.

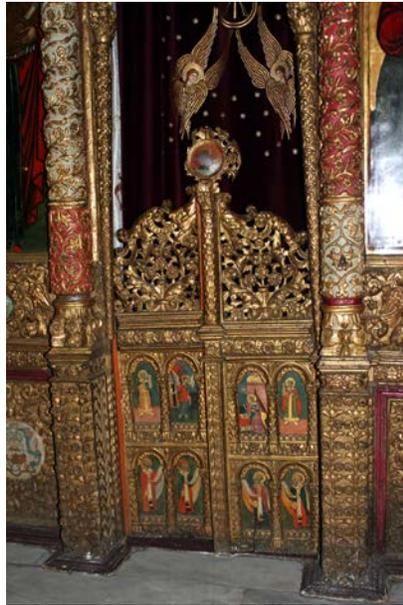
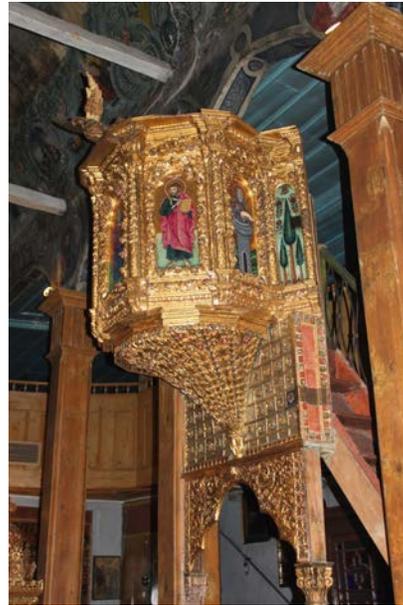
Fig. 2
Wooden interior decoration of "Nea Panagia" church
a - Bema door; b - Pulpit.

From the post-Byzantine decoration also remains in a very good condition the Pulpit and three Icon stands. The quite impressive Pulpit is carved and gilded (Fig. 2b), has polygonal shape, a conical base and is based on one of the columns of the church and additionally on two thinner carved pillars, forming an arch beneath the Pulpit. The ceiling and the loft, dyed with monochrome oil paint, are constructed using flat planks, joined with laths of semicircular cross-section, forming elongated rectangles, a very common structure of that time. The ceiling was decorated all around with an impressive carved wooden frame.

The oldest post-Byzantine church of Thessaloniki is "Nea Panagia", which was built in 1727, while in the mid of 19th century great renovations took place. It is a wooden-roof church, of basilica rhythm, with 2 rows with 7 columns of square cross-section, which divide the interior into three aisles. The columns bear capitals and covering of newer construction (after the earthquake of 1978), made of varnished pine wood. Very impressive is undoubtedly the carved and gilded iconostasis of great height, for which there is no evidence of a clear chronology, but it might have been constructed the latest by mid-19th century (Mantopoulou-Panagiotopoulou 1989). Perhaps, part of this iconostasis may come from an older iconostasis of the church. The entire surface of the iconostasis, from the base to the top, is covered by rich carving, which in several places is pierced. It has also three bema doors, large part of whom, are covered also with pierced carving (Fig. 2a). Generally speaking, the condition of the iconostasis is very good. There are not any obvious rot or insect attacks, nor display of other defects in wood or detachments of different joined pieces of wood, except for only few cases. Special attention has been paid in order to protect the iconostasis from the moisture, derived from the often cleaning process of the church floor. This has been achieved using profiled wood, that is placed around iconostasis base and the surfaces of timber are oil painted, in order to create a hydrophobic layer around wood. The back side of the iconostasis was covered with solid wood or wood based panels and painted using oil paint.

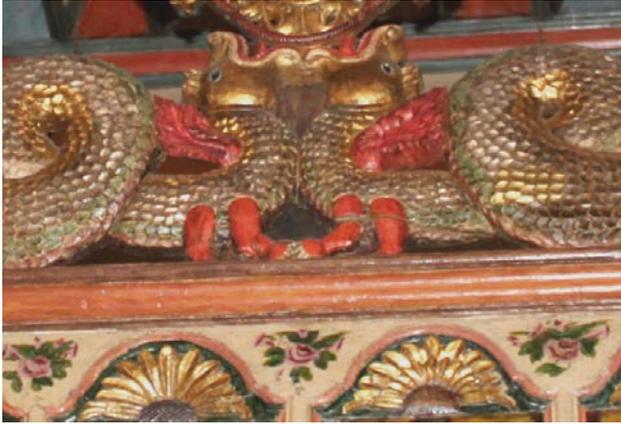
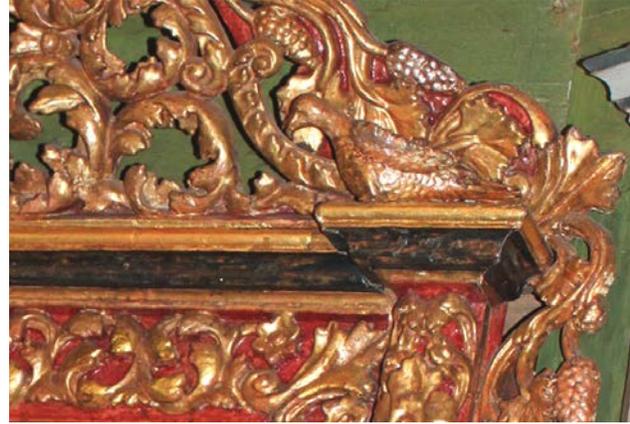
Fig. 3

**Details of wooden interior decoration of "Agios Antonios" church
a - Iconostasis; b - Icon frame.**

The pulpit is based on one of the columns of the church and is constructed and painted, following the same technique as that of the iconostasis. It is a structure of polygonal shape, with 6 sides on the protruding part and the corresponding pyramidal base. In the horizontal wooden roof of the church, the certainly profiled laths, forming various geometric shapes, while in the middle of the surface there is a slightly carved, small rosette. Additionally, in the church there is a magnificent gilded icon frame with pierced carving (Fig. 3b).

The church of "Agios Antonios" differs from the other post-Byzantine churches of Thessaloniki, not only due to its smaller size, but mainly due to the fact that it has only one row of 5 columns that divide the interior space into two aisles. These columns, of circular cross section, are made of wood, have an overlay of a special lime plaster mixture and they are mounted on older marble columns parts, in order to protect the timber from the humidity coming from the floor. The church was built around 1820 (Siaxampani-Stephanou 1985), whereas its current form may have been acquired during its renovation in the early 20th century (Mantopoulou-Panagiotopoulou 1989). The interior decoration of the church is constructed, referring to the most of its part, of flat wooden boards, where other profiled or carved pieces are glued on. The carved parts of the iconostasis are gilded (Fig. 3a), while the rest of its surface is painted with some painted decoration elements. The construction of iconostasis may seem to be simple, due to the limited participation of woodcut parts. Nevertheless, the craftsman achieved to utilize the connection ability of wood, offering to his object a beautiful appearance that is apparent, even without painting. The damage observed in the iconostasis is quite limited and is caused mainly by older insect attack. Also in this case, in order to protect the base of the iconostasis from humidity, certainly profiled wood, which has been oil painted has been placed circumferentially of the base.

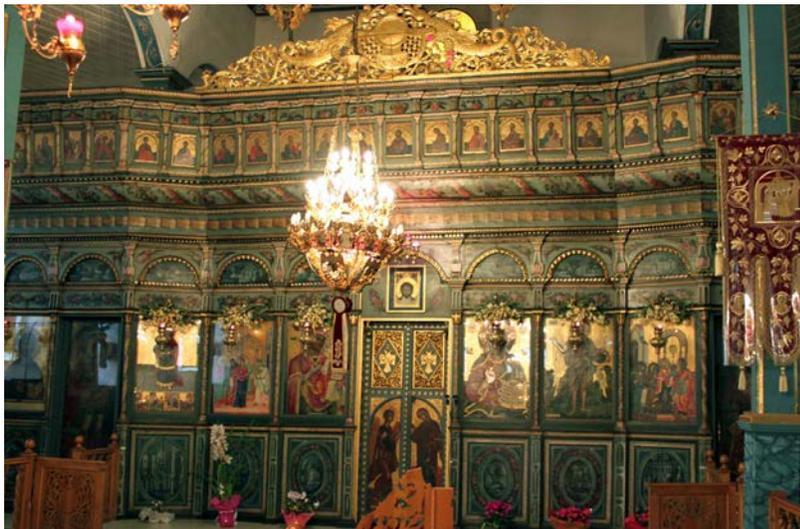
Fig. 4

Wooden iconostasis of "Ypapanti" church.

The impressive wooden decoration of the church "Ypapanti" presents many similarities with that of "Agios Antonios". The sightseer Camus declared in 1896 that the church has beautiful contemporary woodcarvings (Tampaki 1998). The church is also of basilica rhythm without a dome, while it has two rows of 6 wooden square columns that divide the church into three aisles. The columns, also, has chapters and an overlay of painted pine lumber, of newer construction, like in the church of Nea Panagia. The church in its present pattern was formed in 1841 (Mantopoulou-Panagiotopoulou 1989). The tall, painted iconostasis (Fig. 4) was constructed the same year and it also constitutes other previous iconostasis parts. The oldest of its parts, is the central "bema door" with Cretan art paintings of the 16th century (Xyggopoulos 1956) and today it is attached to a newest bema door

behind a protective glass. At the top of the iconostasis there is a gilded, pierced carved pediment. Despite the absence of rich wood carving decoration, the overall construction of the iconostasis lends majestic atmosphere and courtliness to the church. The plenty rectangular and semicircular frames, separated by colonnettes of various shapes (square, semicircular, vase-type) and enriched with capitals and other decorative wooden elements provide a beautiful appearance, which would be quite obvious, as in the church of "Agios Antonios", even without the painting.
