## DAMAGE EVALUATION OF GLULAM TWINNED COLUMNS TO BEAM CIRCULAR BOLTED CONNECTION

*This paper deals with assessment of glulam twinned columns to beam circular bolted connection. This kind of connection is used for embedded assembly. Because of the moisture content variations, cracks often occur in the direction parallel to the grain. The aim of the study is to understand the mechanism responsible of the cracks happening. In the same time, another aim of this study is to evaluate the residual resistance of a damaged assembly.*

*The assembly has been designed according to Eurocode 5. Two different initial conditions have been tested. For the first assembly, the columns and the beam have been dried before machining and tested dry. For the second assembly, the beam was wet and the columns were dry before machining, then the assembly was tested dry. The difference of moisture content implies a huge tensile strain in the direction perpendicular to the grain of the columns before loading.*

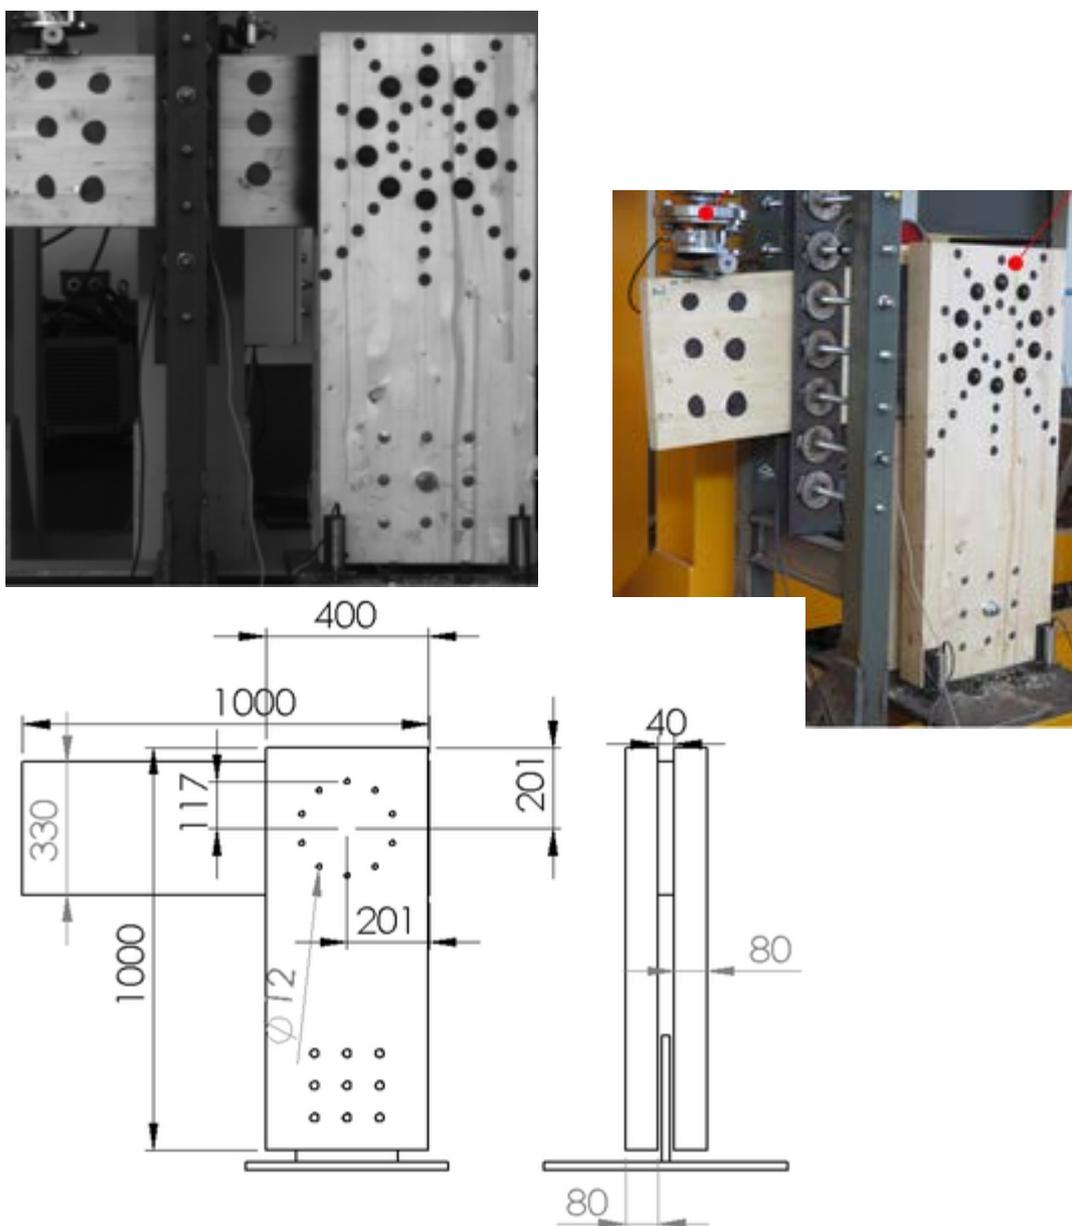
The mechanical behavior of twinned columns to beam circular bolted connections was tested in bending test. The sample geometry and profile is given in Fig. 1. It is composed by GL24 Spruce (picea abies L). The columns thickness is biggest because the study focalized on the beam behavior.

**Fig. 1.**  
**Experimental setup and sample geometry**

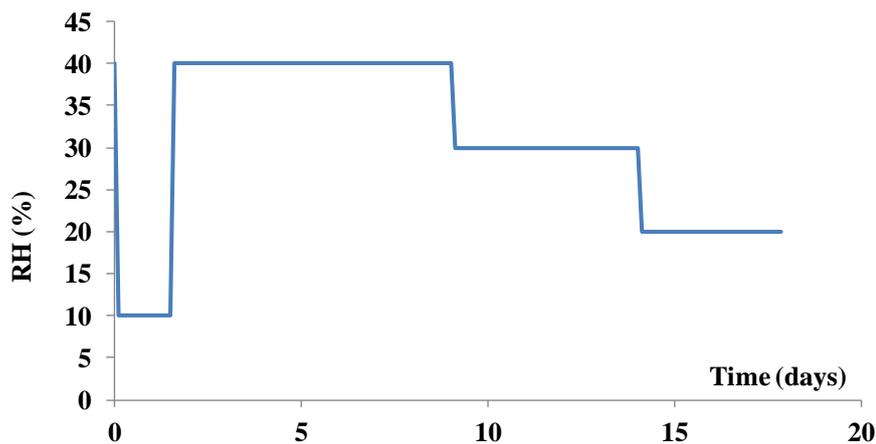
The beam was conditioned at 20°C and 85%RH, about 18%MC and the twinned columns were at 12%MC. After machining, the assembly was conditioned at 20°C and 20%RH but not enough time to obtain equilibrium state. The mean moisture content was about 9%MC. To avoid surface shrinkage cracks, the relative humidity reduction was done step by step as shown in Fig. 3, except from a problem with the conditioning chamber which reach 10%RH for a weekend. During this drying step, the assembly was loaded as shown in Fig. 2. The total load was 1.65kN, which is the maximum load possible in the conditioning chamber.

**Fig. 2.**  
**Conditioning of sample in the chamber**

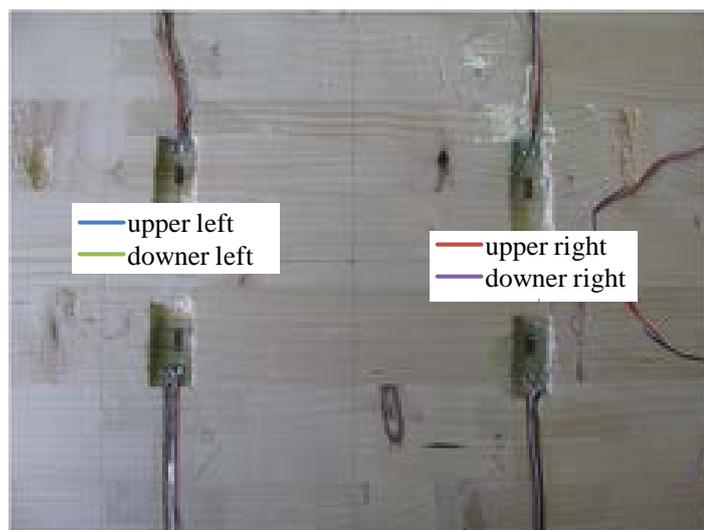
Both of beams were equipped by strain gauges inside the circular connection of the beam in order to know the tensile strength in the direction perpendicular to the grain. The first assembly had only 3 gauges, because of a knot and the second assembly had 4 gauges. Both of them are shown in Fig. 3.

**Fig. 3.**  
**Position of strain gauges on the beam**

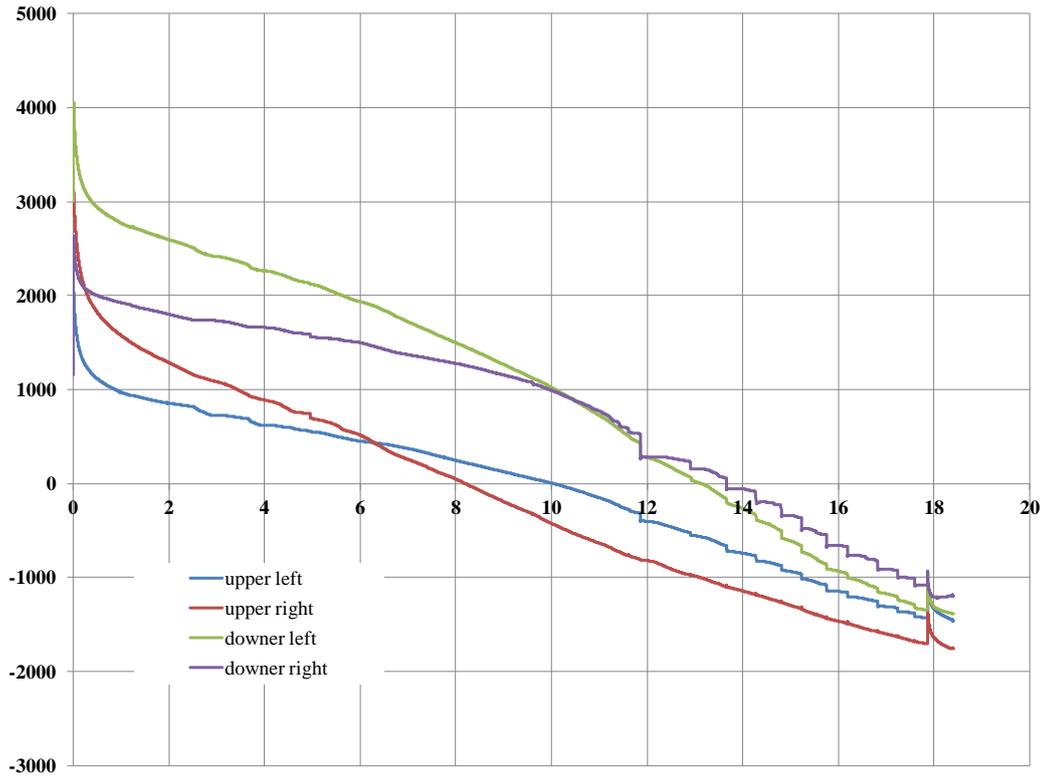
The measurements of the strain gauges inside the circular pattern are shown in Fig. 4. For a change of moisture content from 18% to 9%, the deformation due to shrinkage is about 0.4%. The radial shrinkage coefficient is about 0.1%/MC, so the total strain has to be about 0.9% (Silvaa et al. 2014). There is only 0.4% strain measured by the strain gauges, so there is stress-induced. It should be noted that no crack occurs inside the circular bolt connection, but there is a crack between the connection and the side of the beam.

**Fig. 4.**  
*Strain gauges vs. shrinkage time*

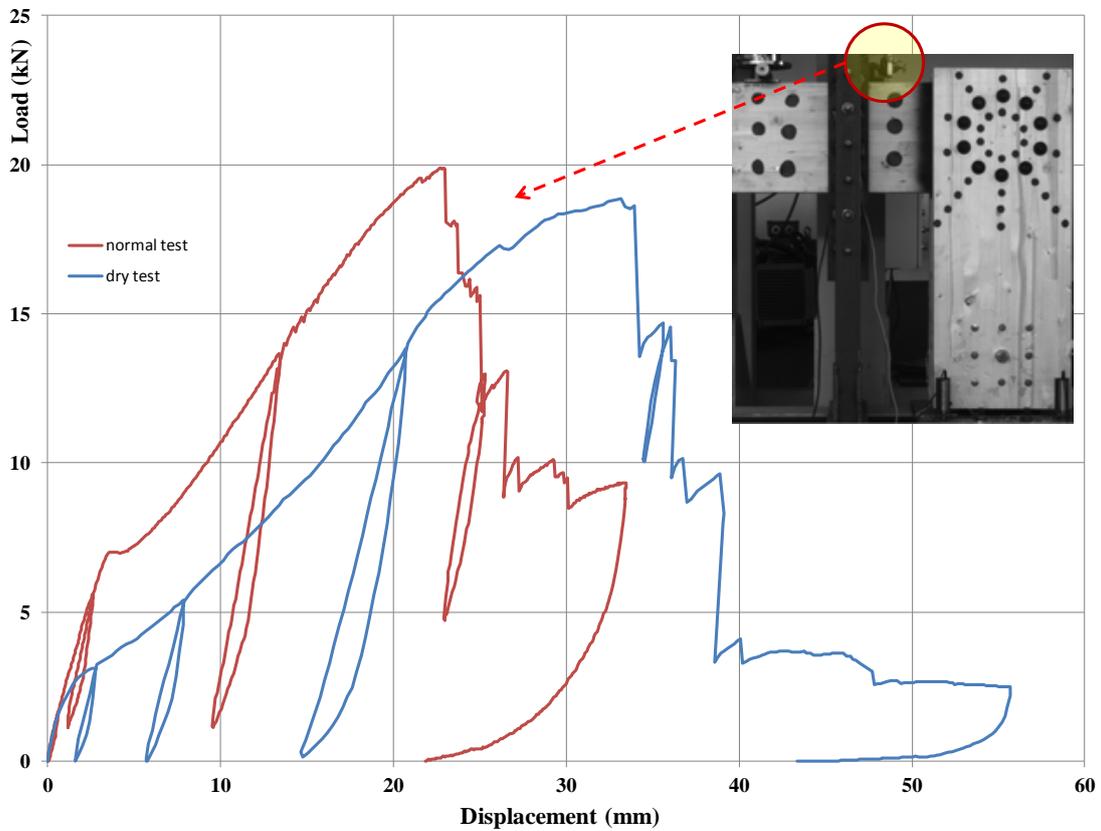
**Fig. 5.**  
*Mechanical response of both assemblies*

The mechanical response of the assemblies is shown in Fig. 5. The figure reveals that, the shrinkage reduced the tension of the bolts so there is less friction. The first step is friction rigidity. The second step is wood bearing capacity and it's possible to see on the graph that the curves are parallel on this phase, so the elastic modulus is about the same. It's interesting to notice that the unloading and loading phases are similar.

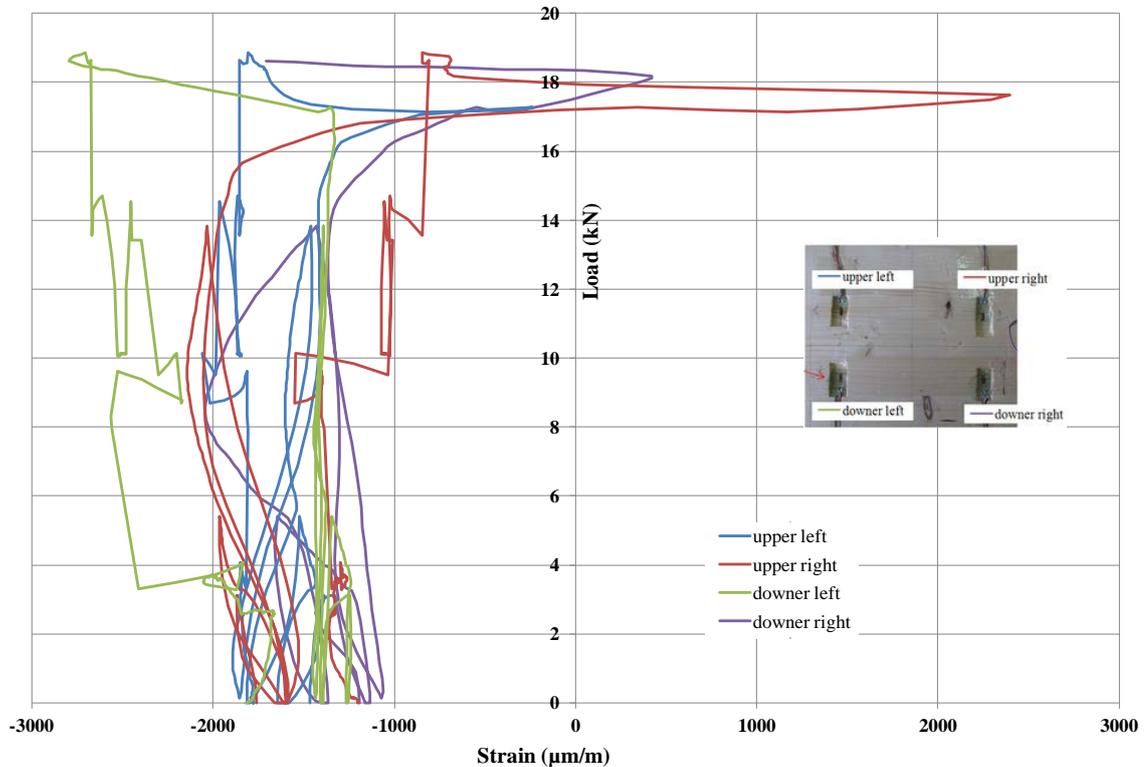
In the same time the strain gauges measurement evolution during the test is plotted in Fig. 6.

**Fig. 6.**  
**Strain gauges evolution during the mechanical test**

The analysis of strain evolution reveals that in the centre of the circular bolt pattern under a load strength of 15kN the strain variation is not important.

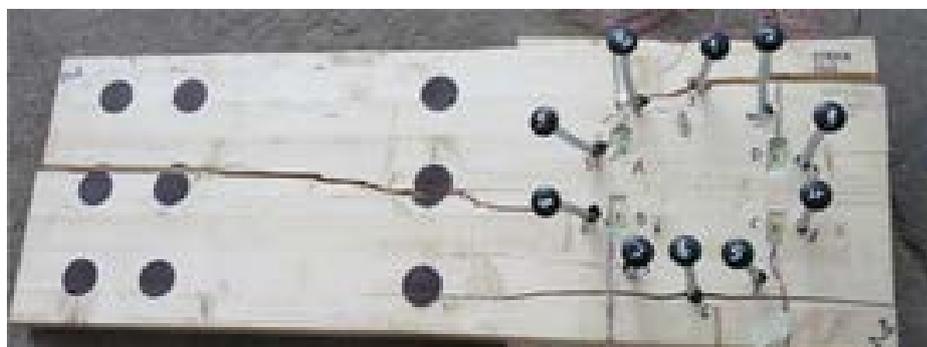
The failure mode of assembly is illustrated in Fig. 7. The picture reveals two cracks from bolt 1 and 6 to the right of the beam. The initial crack is located between bolt 3 and 4 and didn't have any propagation. It's possible to see some crack propagation inside the circular bolt pattern on the dry test beam, it shows less ductility of dry wood.

**Fig. 7.**  
**Failure mode**

This study highlights also the failure mode of assembly, it's possible to see some crack propagation inside the circular bolt pattern on the dry test beam, it shows less ductility of dry wood. There is no important difference of behavior between the two loading conditions, only a little difference of the level of the maximum load strength.

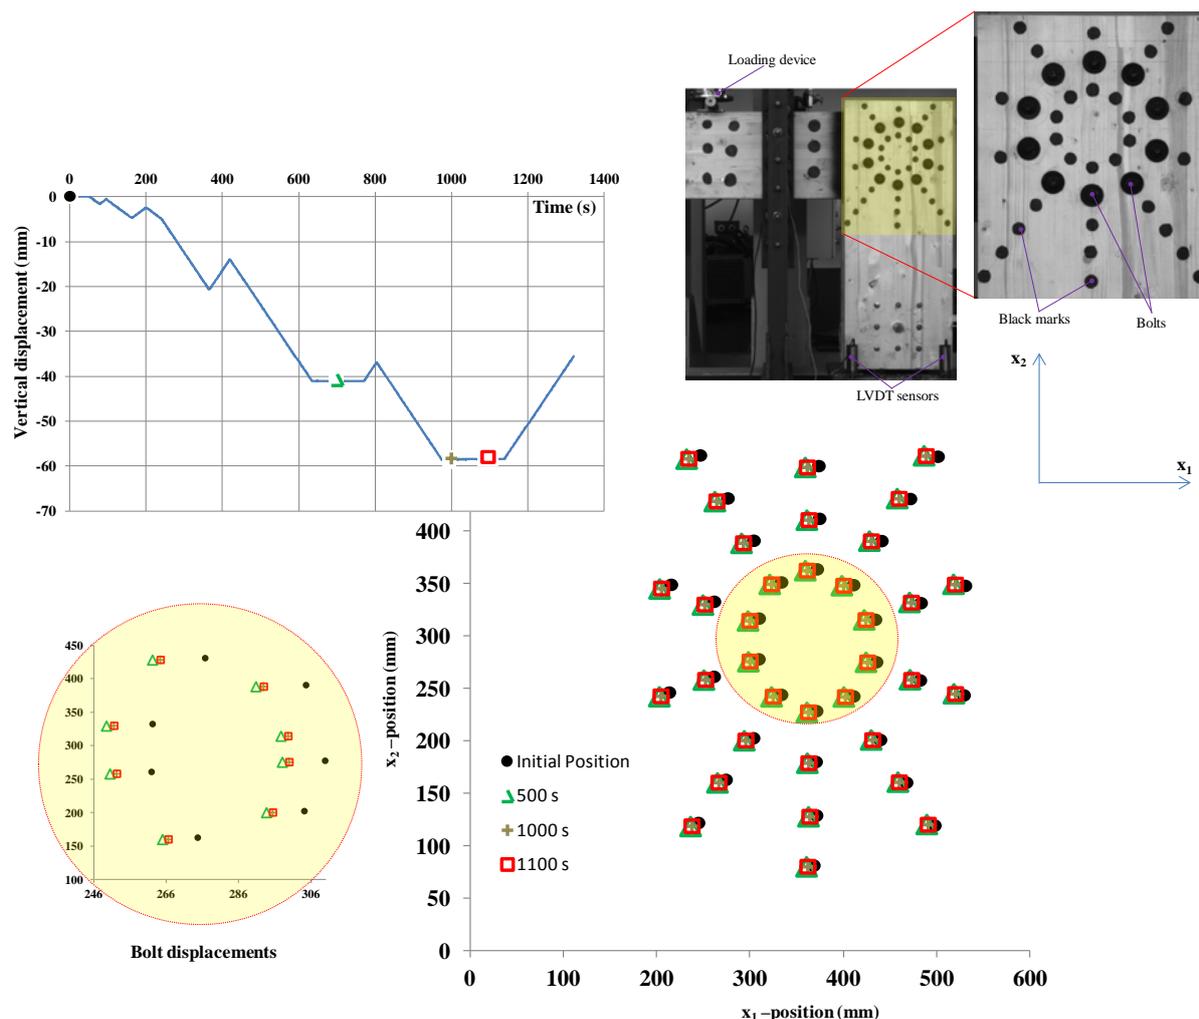
The displacement evolution measured by means of Mark Tracking method is plotted in Fig.8. These displacements correspond to four loading steps given on the loading graph. The analysis of displacement fields on the jointed zone reveals the evolution of the kinematic state during the loading. The displacement analysis allows the evaluation of the rigid body motion and the bolted joint deformation.

**Fig. 8.**  
**Displacement field evolution measured by means of Mark Tracking method**

As in the case of strain gauge measurements, the analysis of displacement by means of Mark tracking method reveals that the strain inside the circular pattern is not important.
